Municipality of Chatham-Kent
Infrastructure and Engineering Services
Parks, Fleet & Facilities
Information Report

To: Mayor and Members of Council
From: Ian Clark, Manager, Parks, Recreation & Cemeteries
Date: April 28, 2023
Subject: Motion for Safety of Swimmers and Watercraft at Eriean Beach

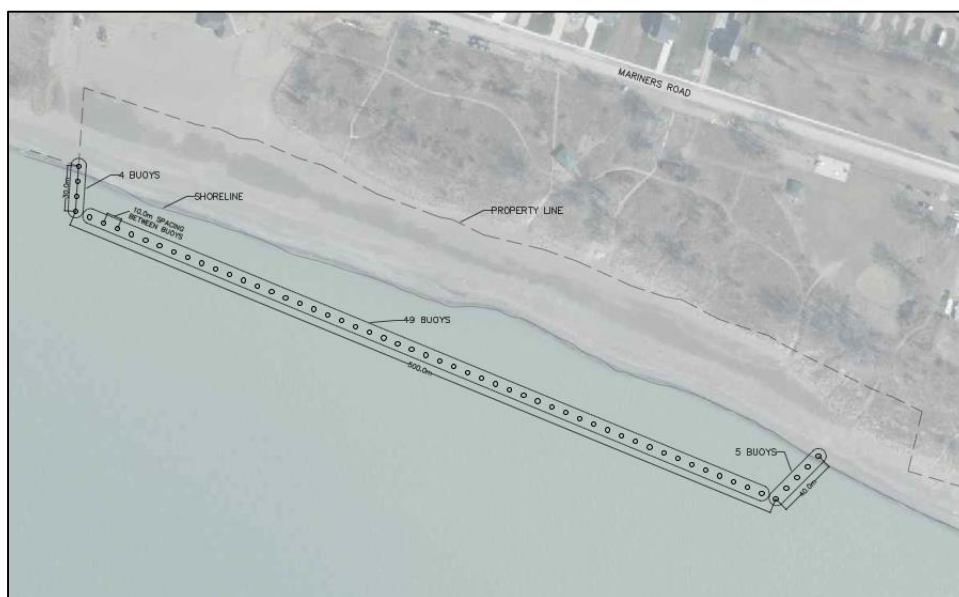
Buoys can be installed where the water is approximately 1.5 meters in depth (10-30 metres from shore). Figure 1 illustrates the conceptional design for buoys spaced 10 metres apart and deployed in a formation beginning at the western public beach boundary and extending approximately 500 metres east towards the pier.

Figure 1: Conceptual Demarcation Buoys Only Design

This option involves individually anchored buoys delineating a space between swimmers and watercraft. Buoys are marked as “Swim Only” in compliance with the Private Buoy Regulations of the Navigation Protection Act. There are no connecting ropes between buoys. Buoys are intended to deter watercraft from entering this area by their presence and markings.

A non-restrictive demarcation buoy system is preferred due to savings on maintenance, conformance with federal regulations, and decreased risk of vandalism due to the lack of rope and shoreline anchor points. This design is used in Mitchell's Bay in the Municipality of Chatham-Kent. The higher capital cost could be mitigated by piloting a smaller buoy deployment zone than depicted in the conceptual design. However, the

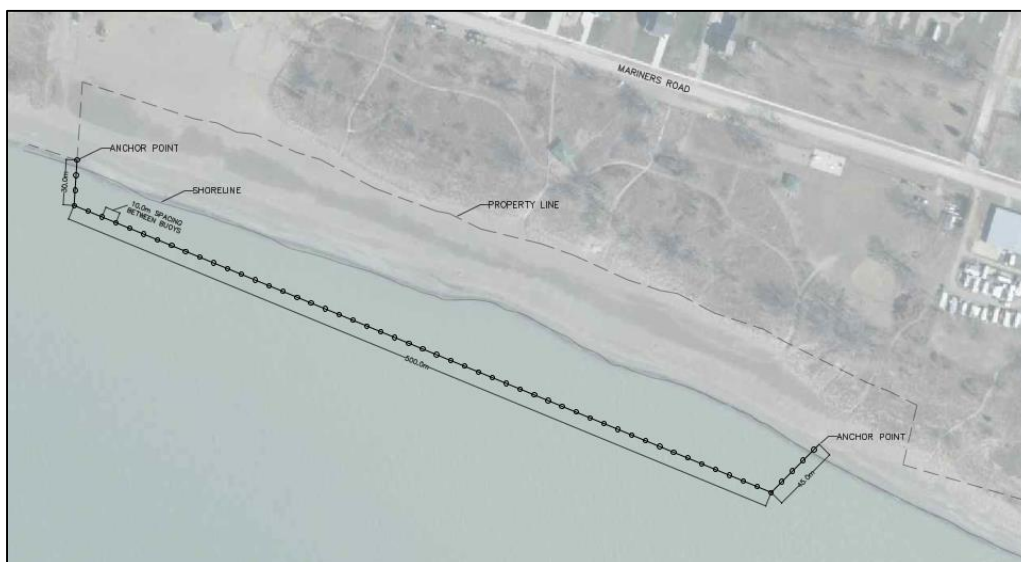
Figure 2 illustrates an enclosed space with an approximate 450-metre perimeter on the western portion of the beach with a shoreline anchor point on either end.

Figure 2: Conceptual Designated Swimming Area Design

An alternative option is to create a roped-off space in the water for recreational swimming. Watercraft would not be permitted inside this designated area. Anchored marker buoys would be connected to swim floats to create an enclosed area up to the shoreline.
