Municipality of Chatham-Kent
Infrastructure and Engineering Services
Engineering and Transportation Division

Subject: Tender Award: Contract T22-294 – McLarty Line over Fields Creek Drain Culvert Replacement, Community of Howard

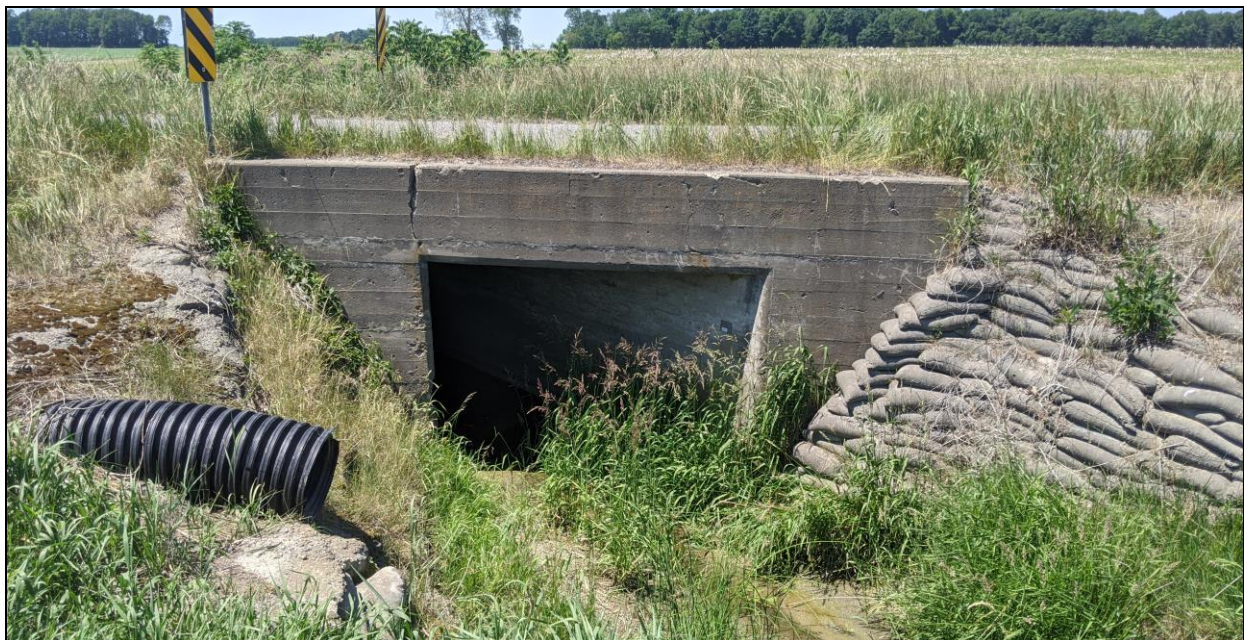
- Severe to very severe movement cracking of the culvert end walls and fascia, potentially resulting in loss of strength.
- Severe deterioration and settlement of the retaining walls, consisting of non-standard “concrete bag” configuration.

Figure 1. McLarty Line over Fields Creek Drain – South Culvert End, showing structural movement cracking on culvert end wall and fascia, and deteriorated state on “concrete bag” retaining walls

- Installation of bird netting and Species at Risk (SAR) Barn Swallow nesting structure prior to construction.
- Installation of site isolation and drain bypass.
- Excavation and removal of the existing concrete culvert including footings.
- Supply and installation of new 2.7 m diameter polymer coated corrugated steel pipe culvert.
- Supply, installation, and compaction of new granular backfill and road base.
- Supply and installation of new rip-rap slope protection at each culvert end.

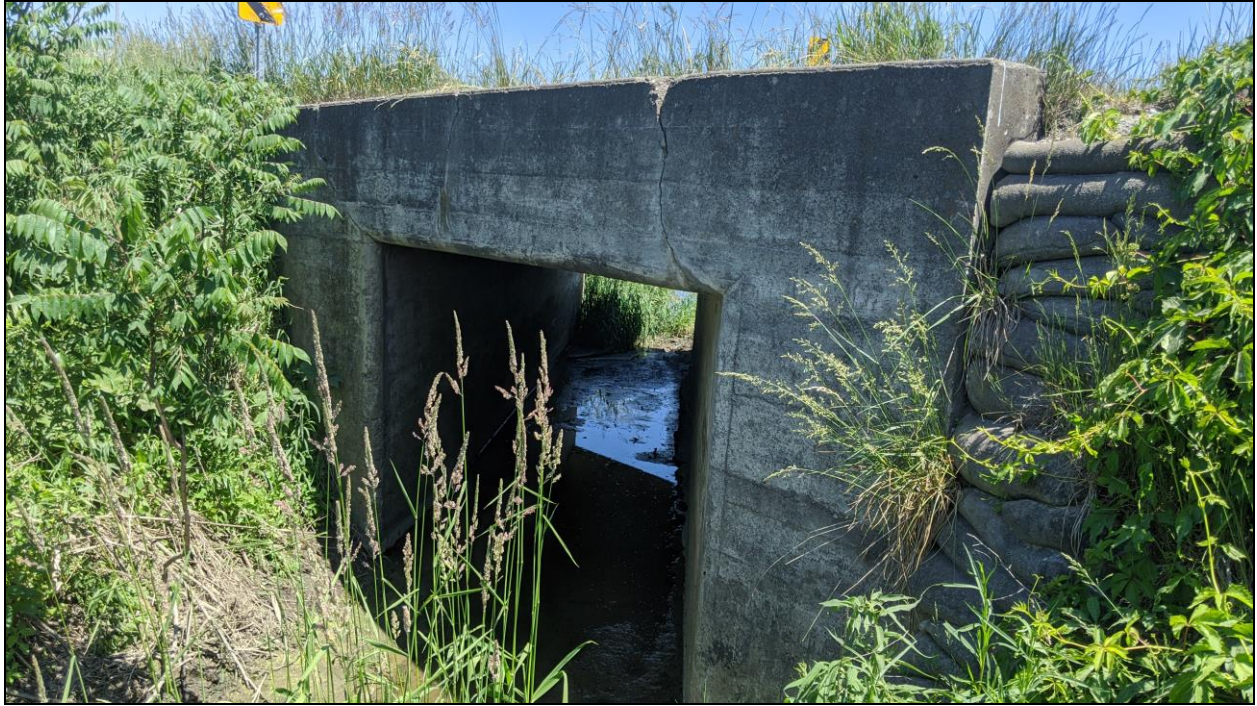
Figure 2. McLarty Line over Fields Creek Drain – North Culvert End, showing structural movement cracking on culvert end wall and fascia, and settlement “concrete bag” retaining walls.

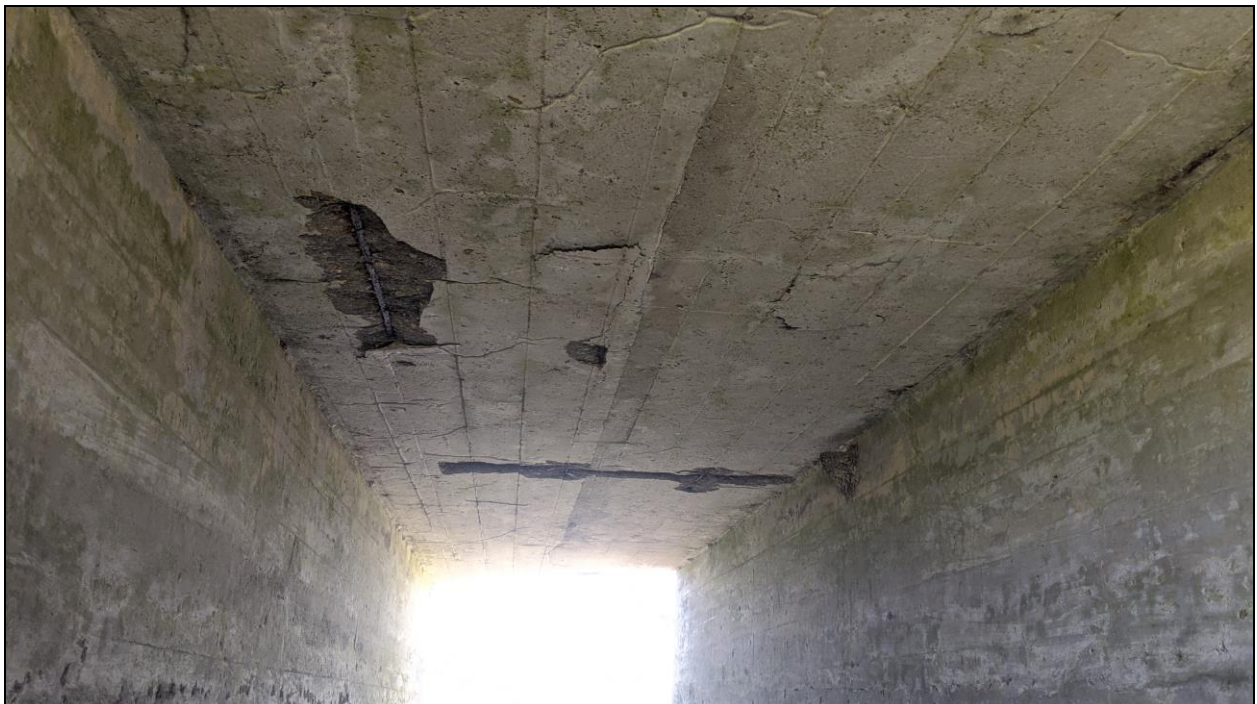
- Isolated severe to very severe delamination of the underside of concrete deck, most likely resulting is loss of strength. Also causes an overhead safety concern.

- Isolated severe to very severe spalling on the interior surfaces of the culvert barrel.
- Severe to very severe corrosion of exposed reinforcing steel.

Figure 3. McLarty Line over Fields Creek Drain – Interior Culvert Surfaces, showing severe delamination and spalling with exposed corroded rebar, as well as an observed Barn Swallow nest
